Technische Mitteilung Nr. 19/2019 Reparatur von Front-Stoßängerverkleidungen Tesla Fahrzeuge

BR-17-10-004 R1
October 10, 2017

Body Repair Tech Note: Repair Guidelines for Front Bumper Fascias

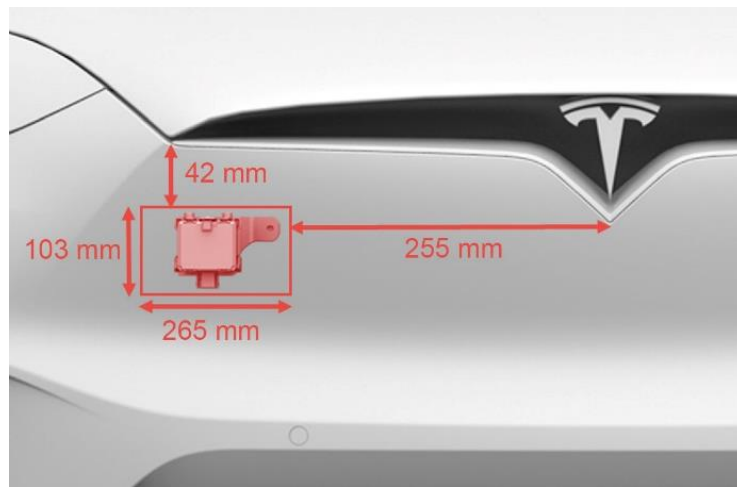
Figure 1 (Model X)

The maximum paint thickness in the radar area (Figures 1, 2, and 3) on a front bumper fascia is 300 microns (12 mils). 300 microns (12 mils) is approximately 1 factory coat and 1 recoat.

If a front bumper fascia requires repainting for a 2nd or 3rd time, all paint must be removed in the radar area (Figures 1, 2, and 3) down to the base plastic before repainting, or the front bumper fascia must be replaced.

- Do not perform any repairs in the radar area (Figures 1, 2, and 3). Repairs include adding plastic filler, gluing, plastic welding or stapling, or leaving a feathered paint edge.
- Remove all paint in the radar area (Figures 1, 2, and 3) down to the base plastic if refinishing the front bumper fascia will result in a film thickness greater than 300 microns (12 mils) in the radar area.

⚠ CAUTION: Avoid removing the base plastic material in the radar area. The radar sensor is calibrated to the factory thickness of the plastic. Removing excessive plastic material in this area might result in incorrect radar function.
